# New Hampshire Volunteer Lake Assessment Program

## 2002 Interim Report for Pawtuckaway Lake Nottingham

NHDES  
Water Division  
Watershed Management Bureau  
6 Hazen Drive  
Concord, NH 03301

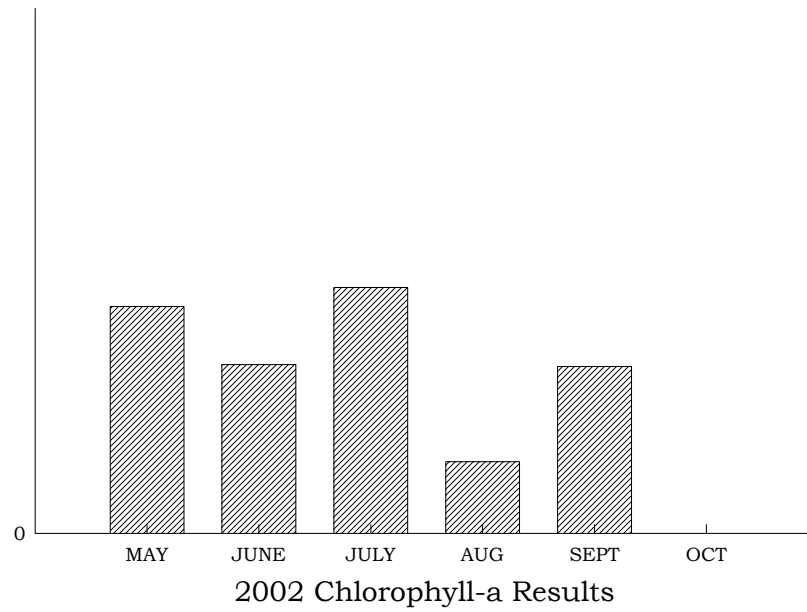
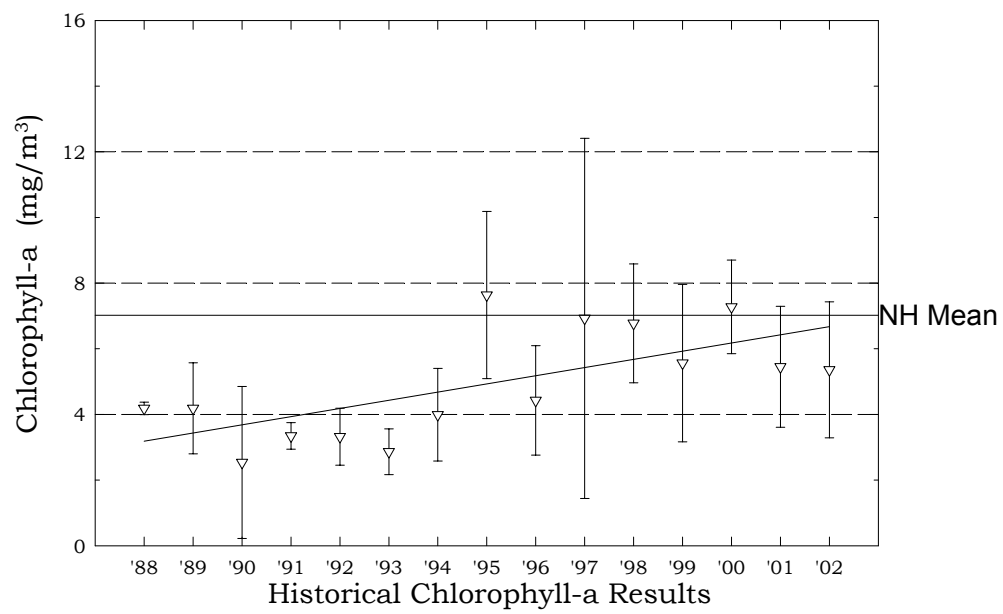
- **Figure 1 and Table 1:** The graphs in Figure 1 (Appendix A) show the historical and current year chlorophyll-a concentration in the water column. Table 1 (Appendix B) lists the maximum, minimum, and mean concentration for each sampling season that the lake has been monitored through the program.

For the **NORTH STATION**, the historical data (the bottom graph) show that the 2002 chlorophyll-a mean is **less than** the state mean. Overall, visual inspection of the historical data trend line (the bottom graph) shows **a variable, but overall increasing**, in-lake chlorophyll-a trend. This would mean that the chlorophyll-a concentration has somewhat fluctuated, but since monitoring began the concentration has generally **worsened**.

The mean annual chlorophyll concentration was ***approximately the same*** at the NORTH and SOUTH stations this season.

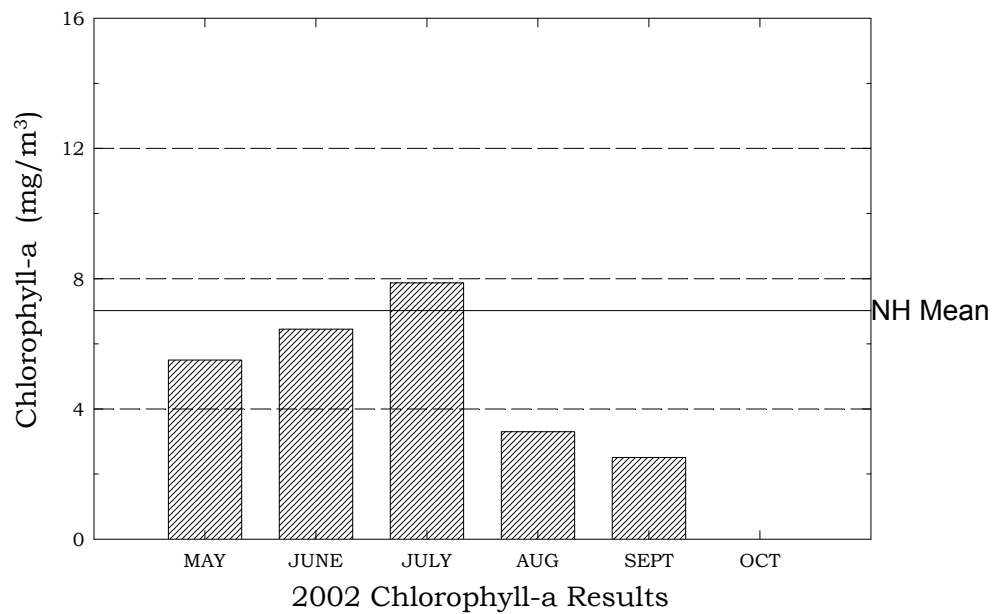
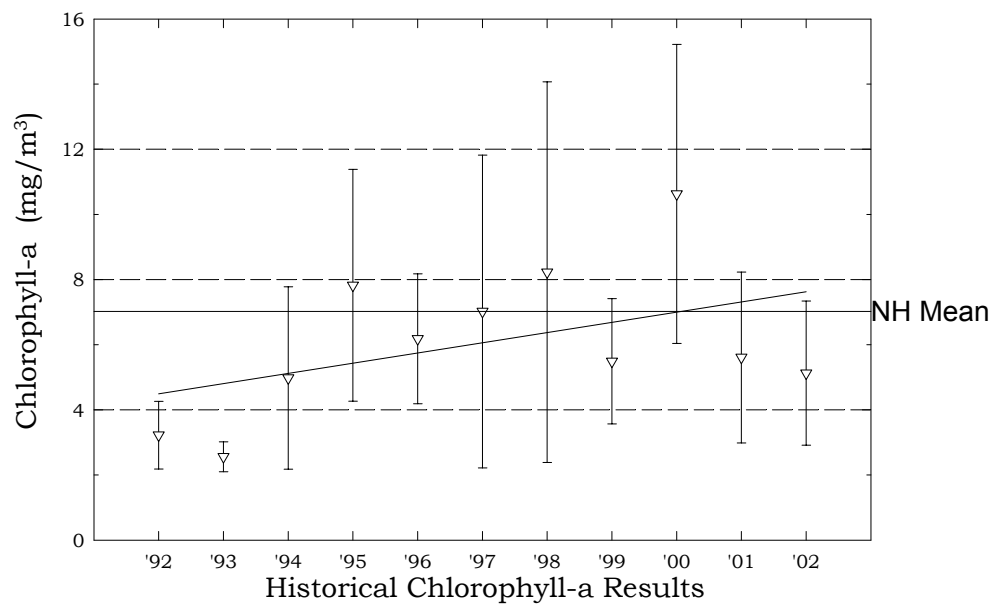
**Figure 1.** Monthly and Historical Chlorophyll-a Results

For the **SOUTH STATION**, the historical data (the bottom graph) show that the 2002 chlorophyll-a mean is ***less than*** the state mean. Overall, visual inspection of the historical data trend line (the bottom graph) also shows ***a variable, but overall increasing***, in-lake chlorophyll-a trend. This would mean that the chlorophyll-a concentration has somewhat fluctuated, but since monitoring began the concentration has generally ***worsened***. (However, it is important to note that the mean annual chlorophyll concentration has decreased since 2000. We hope this trend continues!)

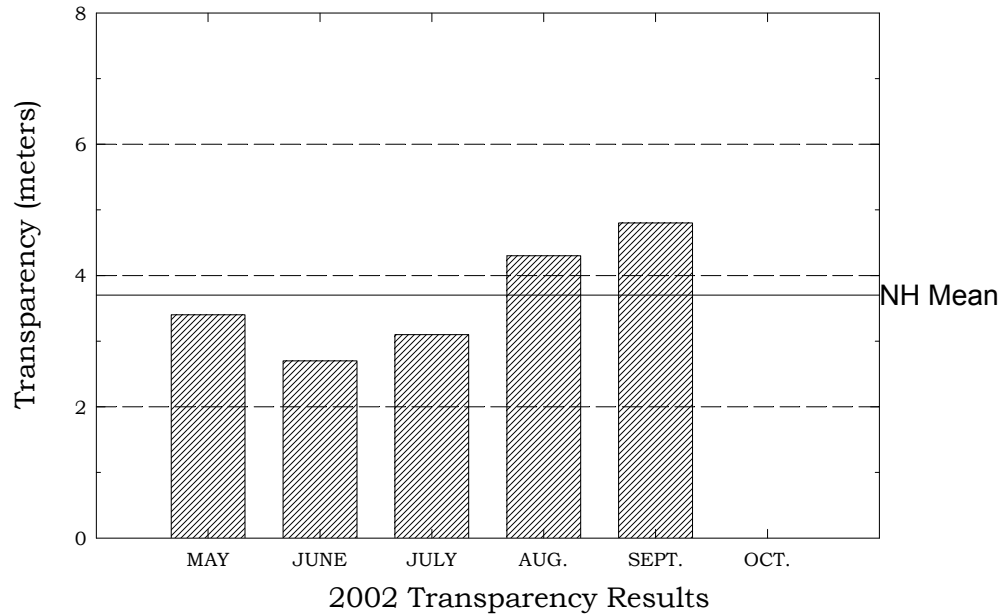
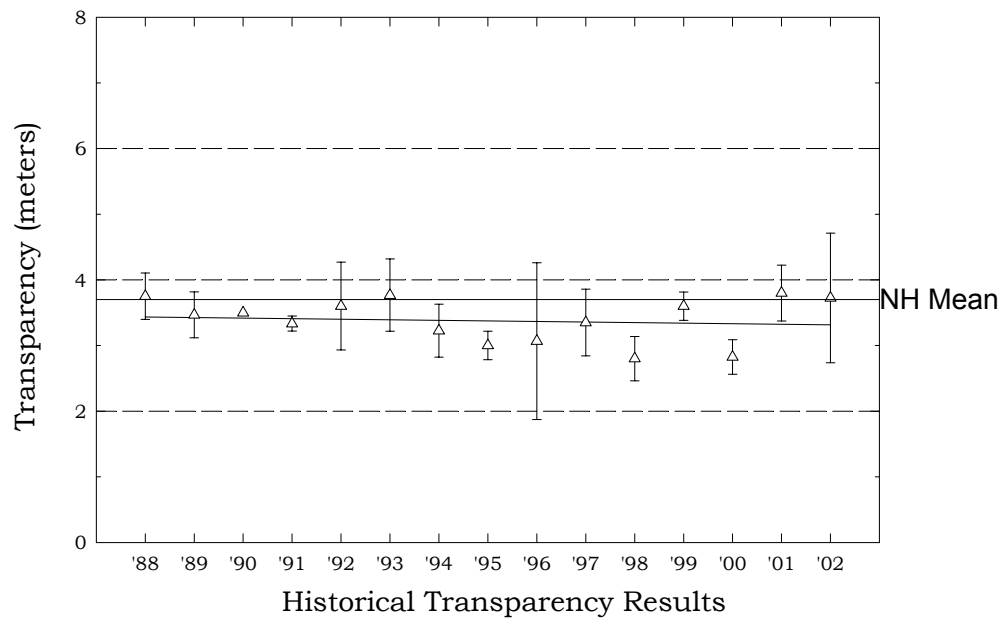
**Figure 2.** Monthly and Historical Transparency Results

- **Figure 2 and Table 3:** The graphs in Figure 2 (Appendix A) show historical and current year data for lake transparency. Table 3 lists the maximum, minimum and mean transparency data for each sampling season that the lake has been monitored through the program.

For the **NORTH STATION**, the historical data (the bottom graph) show that the 2002 mean transparency is ***approximately equal to*** the state mean.

Overall, visual inspection of the historical data trend line (the bottom graph) shows ***a relatively stable*** trend for in-lake transparency, for the **NORTH** and **SOUTH** station. Specifically, the mean annual transparency has at both stations has generally ranged between approximately 3 and 4 meters since monitoring began.

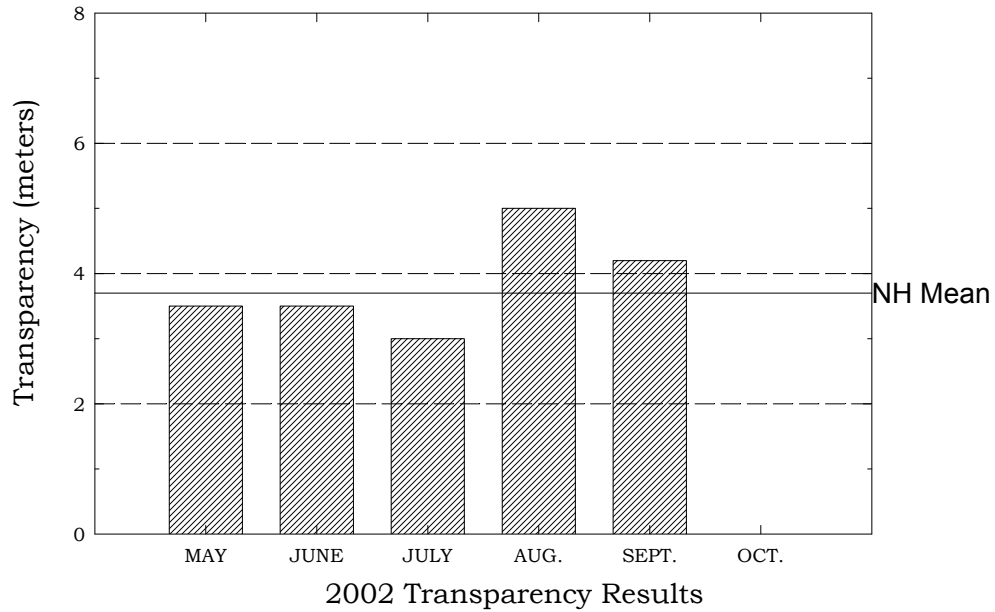
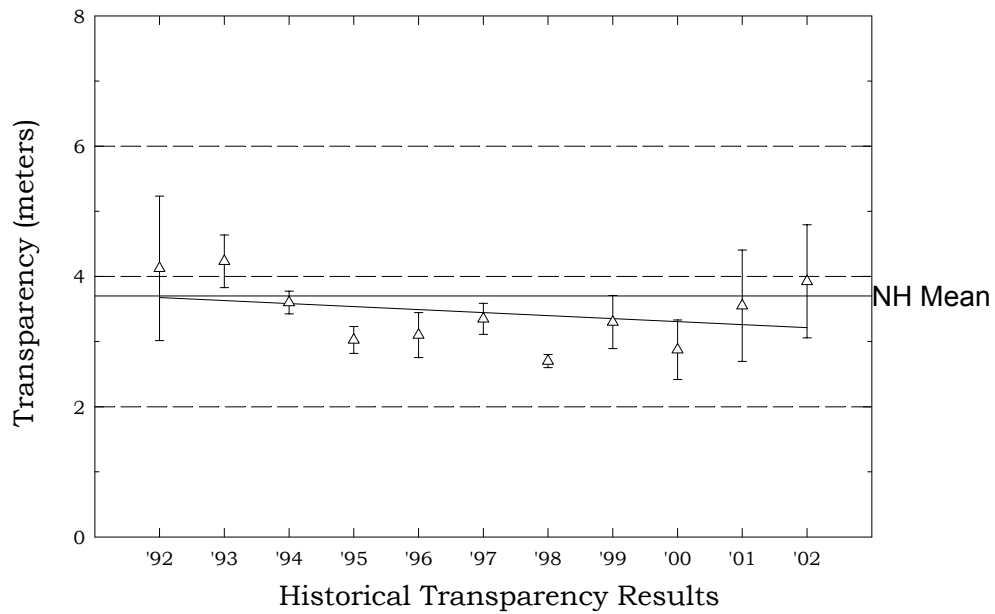
**Figure 2.** Monthly and Historical Transparency Results

For the **SOUTH STATION**, the historical data (the bottom graph) show that the 2002 mean transparency is slightly ***greater than*** the state mean. It is worthy to note that the transparency results have slightly increased for the past three years; we hope this trend continues!

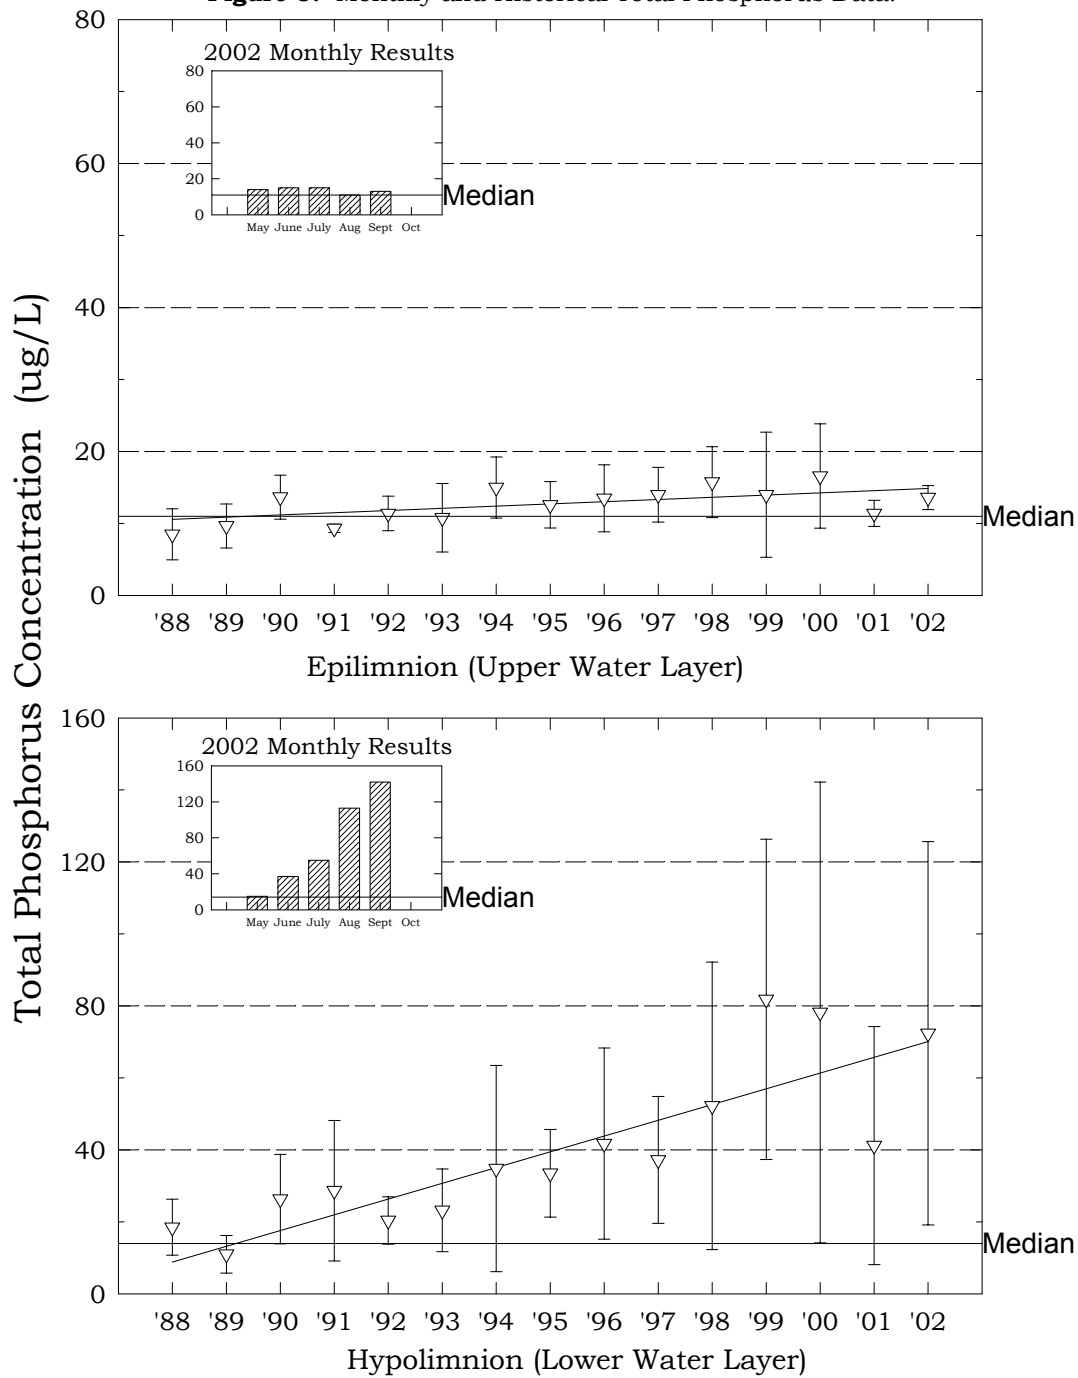
**Figure 3.** Monthly and Historical Total Phosphorus Data.

- **Figure 3 and Table 8:** The graphs in Figure 3 (Appendix A) show the amounts of phosphorus in the epilimnion (the upper layer) and the hypolimnion (the lower layer); the inset graphs show current year data. Table 8 (Appendix B) lists the annual maximum, minimum, and median concentration for each deep spot layer and each tributary since the lake has joined the program.

For the **NORTH STATION**, the historical data for the epilimnion (upper layer) show that the 2002 total phosphorus mean is slightly **greater than** the state median. Overall, visual inspection of the historical data trend line for the epilimnion shows a relatively **stable** total phosphorus trend, which means that the concentration has remained **approximately the same** in the epilimnion since monitoring began.

The historical data for the hypolimnion (lower layer) show that the 2002 total phosphorus mean is **much greater than** the state median. Overall, visual inspection of the historical data trend line for the hypolimnion shows **an increasing** total phosphorus trend, which means that the concentration has **worsened** in the hypolimnion since monitoring began. It is important to note that the total phosphorus concentration steadily increased in the hypolimnion throughout the summer (see 2002 monthly results graph insert). This may be due to decreasing dissolved oxygen levels during the summer months, causing **internal phosphorus loading**. Further discussion of internal loading is found in the interpretation of Table 10 in the next section of this report.

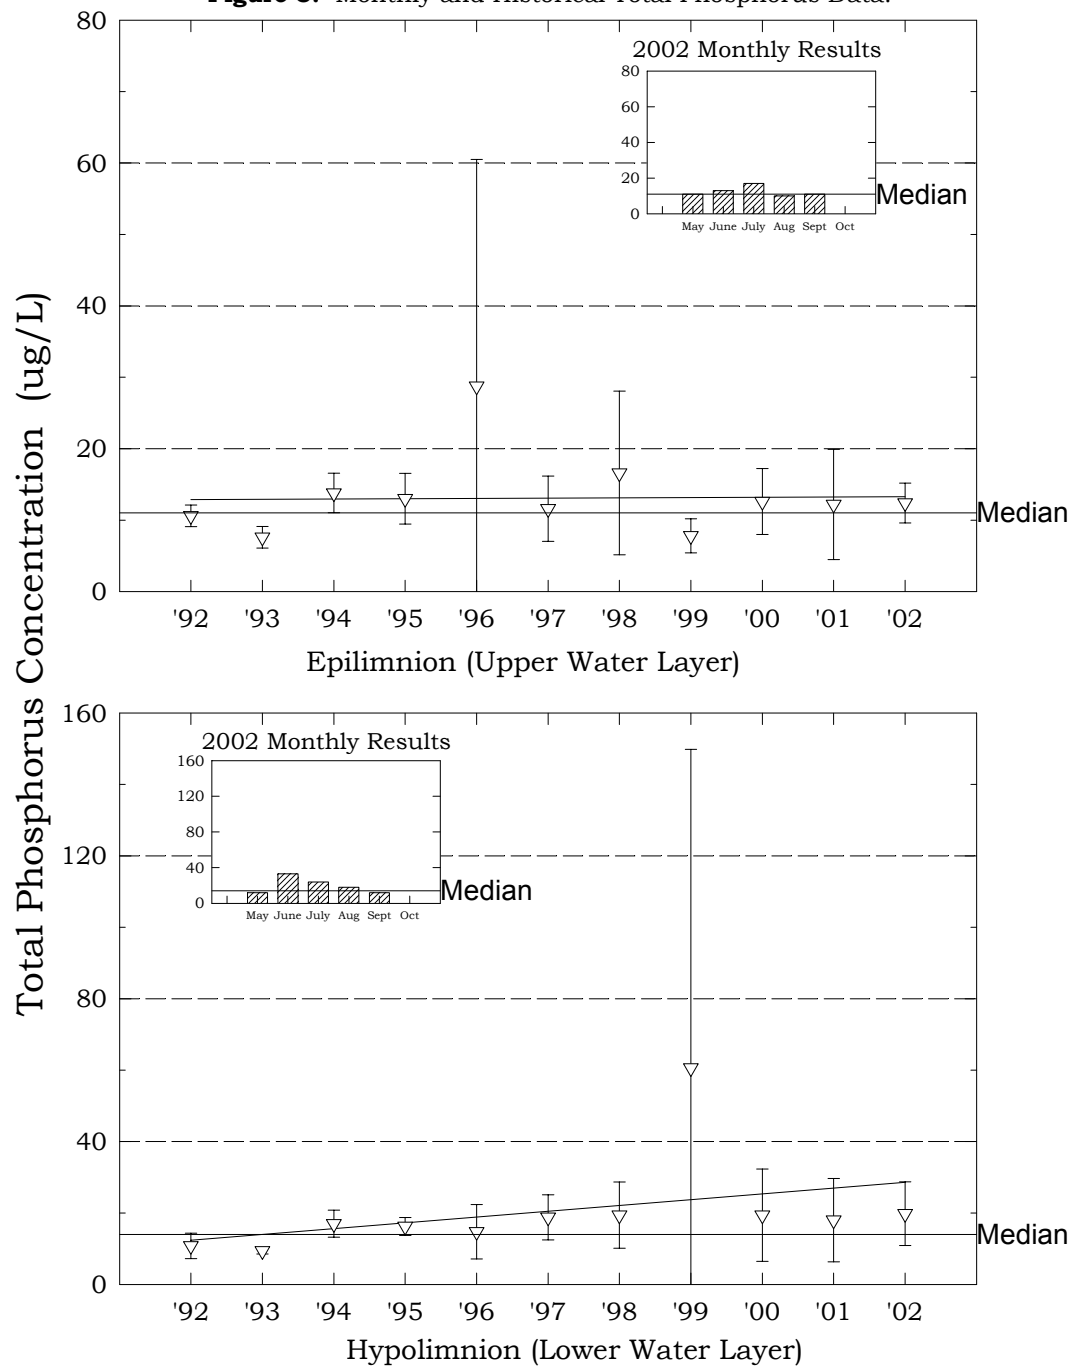
**Figure 3.** Monthly and Historical Total Phosphorus Data.

For the **SOUTH STATION**, the historical data for the epilimnion (upper layer) show that the 2002 total phosphorus mean is slightly **greater than** the state median. Overall, visual inspection of the historical data trend line for the epilimnion shows a relatively **stable** total phosphorus trend (with the exception of a high concentration in 1996), which means that the concentration has remained **approximately the same** in the epilimnion since monitoring began.

The historical data for the hypolimnion (lower layer) show that the 2002 total phosphorus mean is **greater than** the state median. Overall, visual inspection of the historical data trend line for the hypolimnion shows **a variable** total phosphorus trend, which means

that the concentration has *fluctuated* in the hypolimnion since monitoring began.
